## 4 Example Street Arrowtown

- 2.1 This report was commissioned by **Joe Bloggs**  
In accordance with instructions I inspected the property at:  
**4 Example Street, Arrowtown**

Date: 03/03/2018 and report as follows:

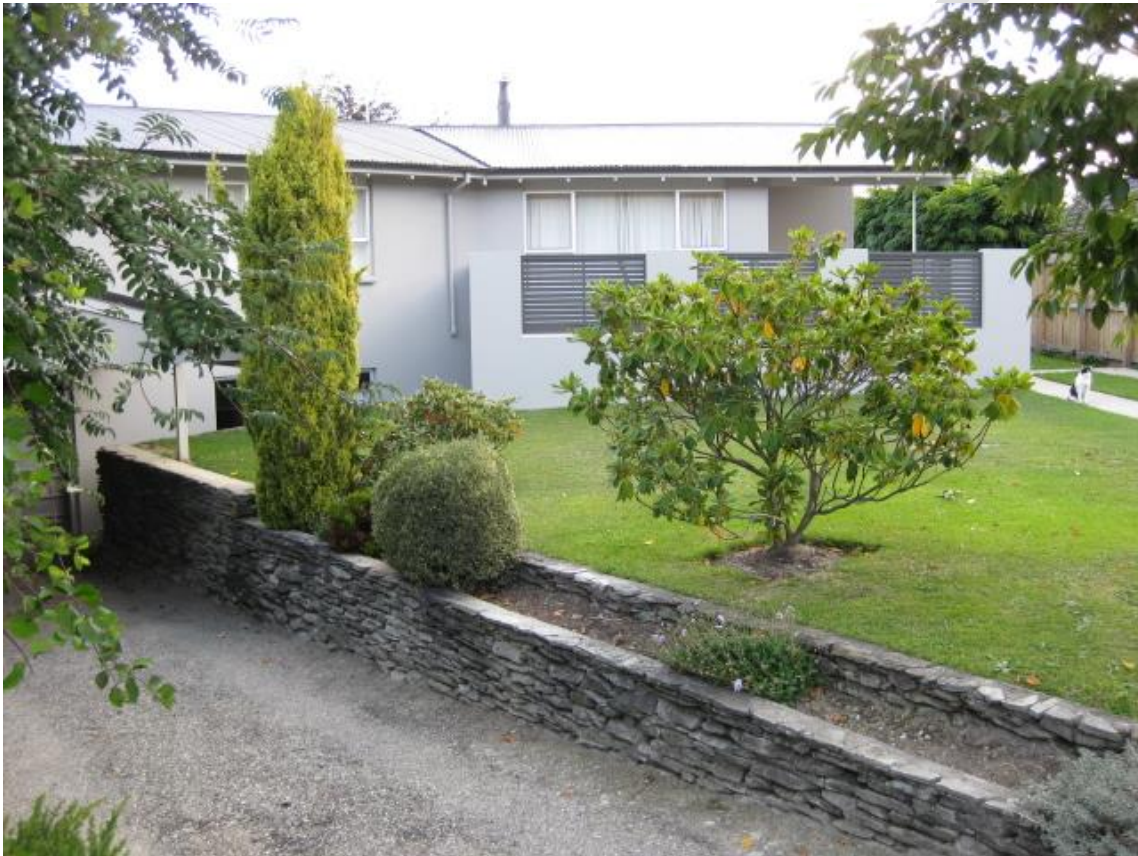
Front of dwelling

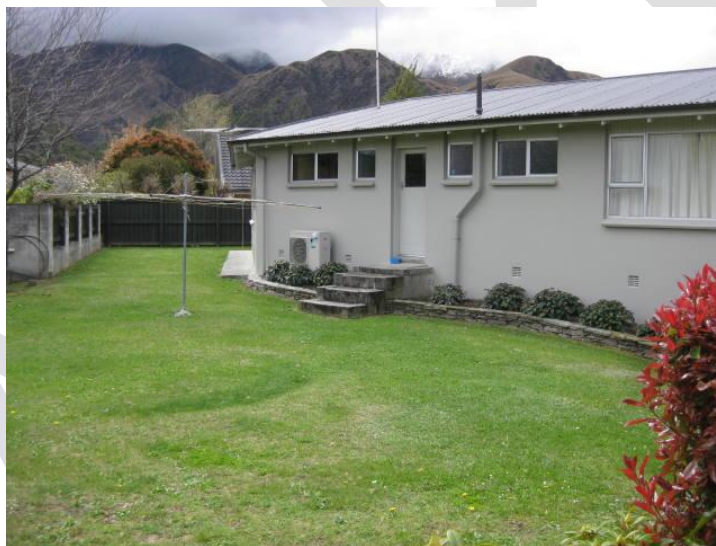
Rear of dwelling

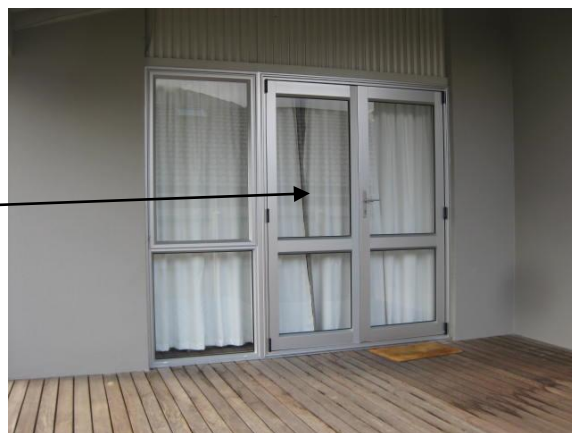
Reasonable for age.

Entrance door

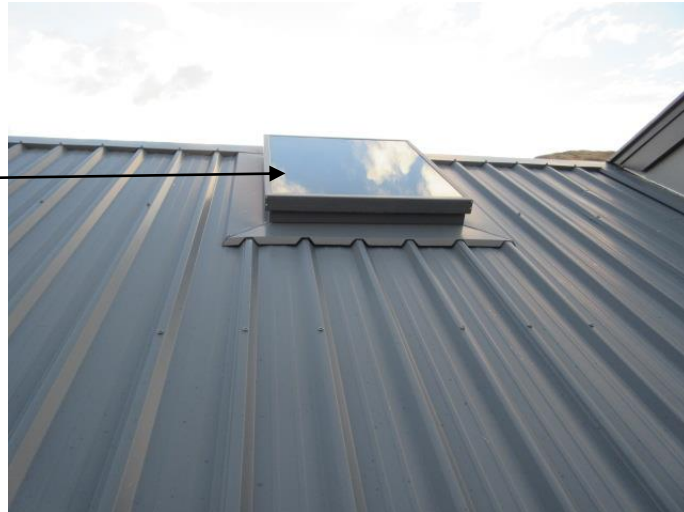
4.8

Over hallway on right side of dwelling.  
Reasonable for age.  
Fixed.  
Appear to be adequate.

Roof Light

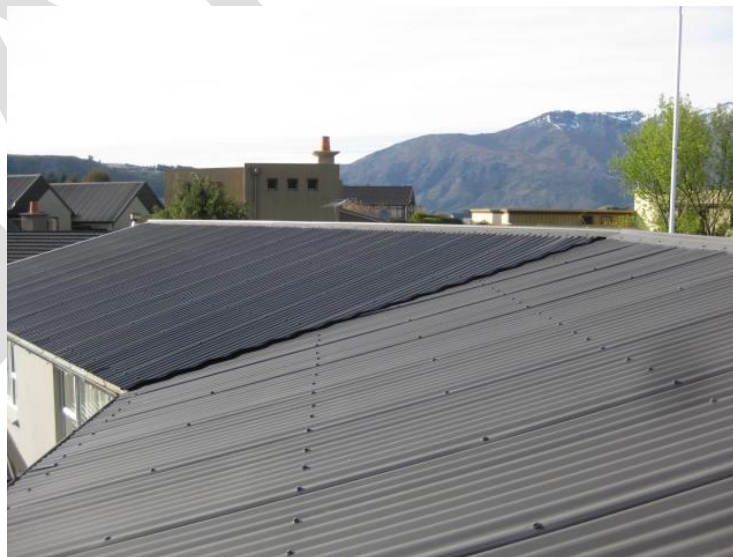
4.9

Painted corrugated iron and Colorsteel 'Five High' profile.  
Reasonable for age.  
Appear to be adequate.  
Appear to be adequate.

Note: Roof has been recently re-painted.

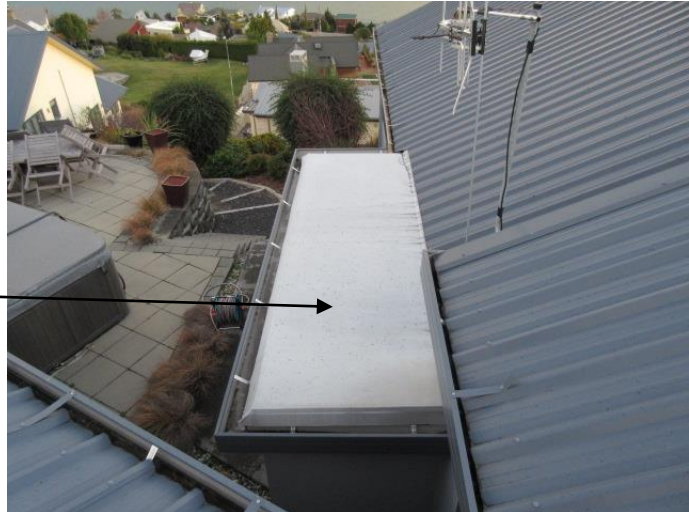
4.10

The joints appear to be in reasonable condition for age.

The fall appears to be running the right way to disperse the rain water.

Membrane roof

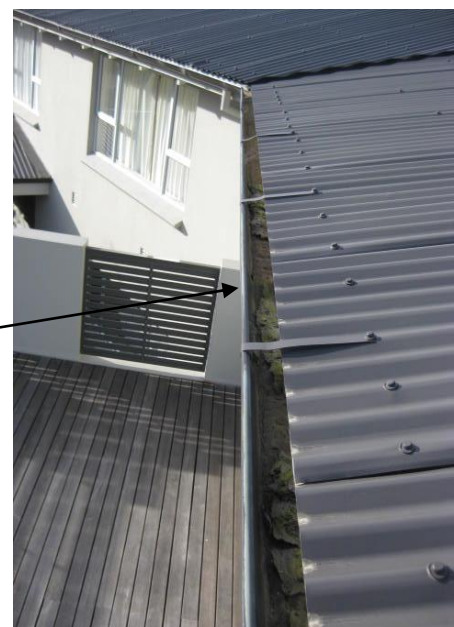
4.11

The spouting is in reasonable condition for age.

The spouting was not leaking at the time of inspection.

The fascia is painted and in reasonably tidy condition.

Spouting

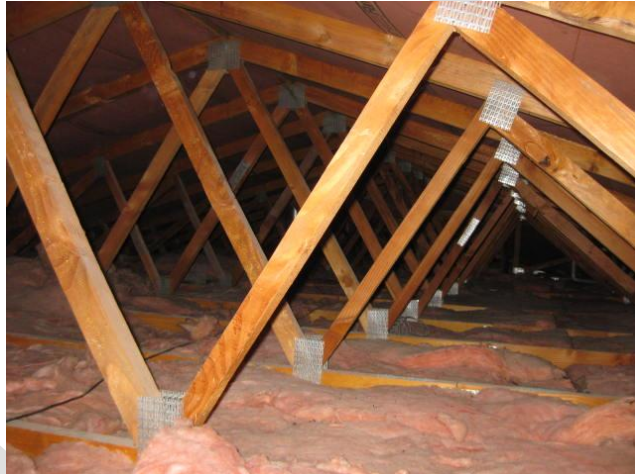
4.12

Inspection revealed the roof framing to be in tidy condition for age of the dwelling and provided the required support for the roof cladding.

No apparent leaks were seen in the roof space at the time of inspection.

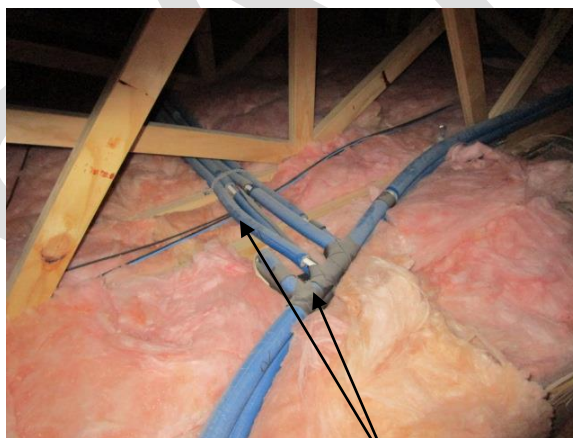
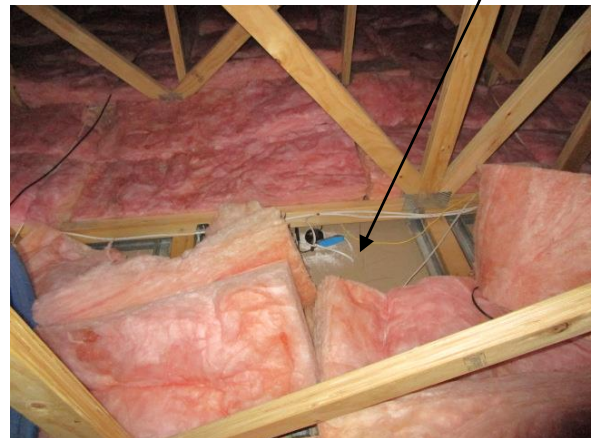
4.12a

**Note:** Some of the insulation has been displaced, requires refitting correctly. (arrowed)

Have fireplace/flue cleaned and checked.  
The bottom of the exterior window and door channels and drain holes require cleaned out around dwelling.  
Have ceiling insulation in the roof space fitted correctly.  
Have insulation on the water pipes in the sub floor space pulled together and then taped together, and fit new insulation where required.  
Repair fence at rear of property.  
Repair driveway if required.  
Have wardrobe door in Bedroom 1 repaired.  
Have a registered gas fitter check the gas appliances. (every 5 years)  
Clean out spouting/guttering around dwelling, and re-check internal gutter when dried out.  
There is a small plant room at the rear of the garage. The floor appears to be damp. Unknown if this is condensation from the diesel burner and water pumps; requires checking.  
The small interior and exterior garage doors require adjusting.  
The cover plate for 1x of the door locks is missing on the right side small exterior garage door.

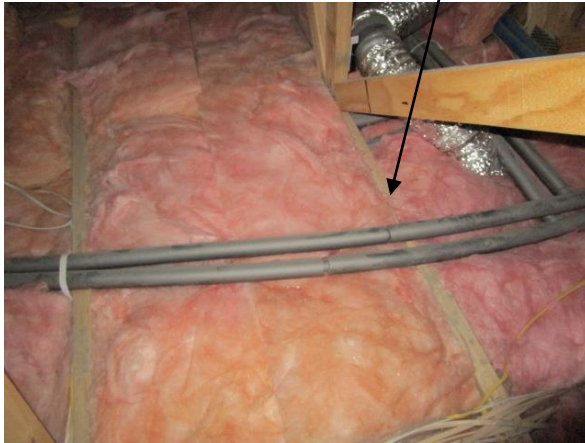
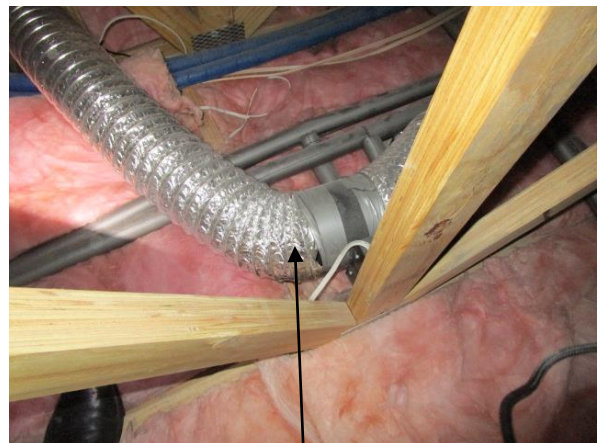
**Note:** The insulation on the water pipes for the radiator heating system require to be pulled together and taped together. (arrowed)

Note: The insulation on the water pipes in the roof space requires to be pulled together then taped together in some areas. (arrowed)

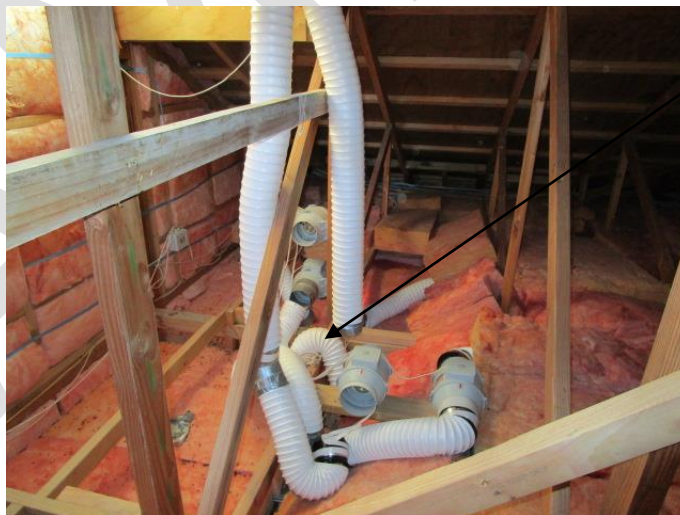
Note: There is a hole in one of the flexible vent pipes in the roof space.

Note: The venting pipes for the bathrooms etc. have been dislodged; requires rectifying. (arrowed)

Some of the interior timber window frames and sashes are due for re-painting to maintain.  
The rain head and spouting on the right side of the conservatory is leaking and the joint on the barge flashing has opened up.  
The venting pipes for the bathrooms etc. have been dislodged; requires rectifying.  
1x of the kitchen sliding windows is hard to operate, requires easing.  
The interior of the some of the Bi-folding doors may require re-painting in the near future to maintain.  
The sliding door from the 2nd living room to the hallway has scratches on 1x side. May require re-painting.  
The fly screen on one of the 2nd entrance area windows requires repairs.  
1x of the opening window sashes in Bedroom 1 is slightly damaged, requires repairing and re-painting.  
The light in the interior 2<sup>nd</sup> toilet is not operating, may require the light bulb to be changed.  
The bracket which holds the flexible shower rose in place in ensuite 1 requires tightening.

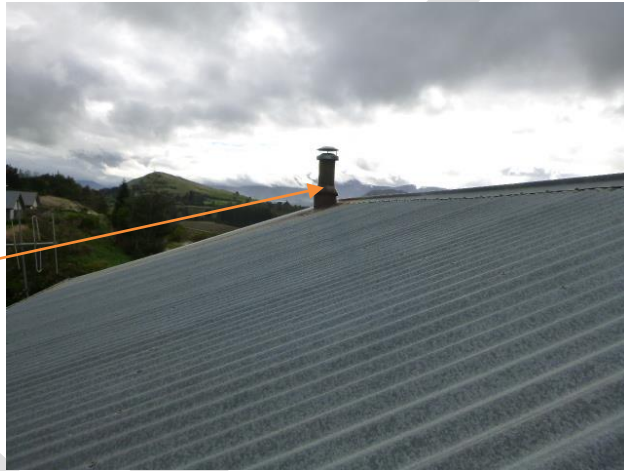
1x chimney flue at this dwelling.  
Stainless steel flue in a galvanised liner.  
Appear to be adequate.

Chimney/flue

Note: The inside of a chimney and fireplace should be cleaned and checked for deterioration before you first use it. This cleaning should then be done at least once a year depending on extent of use and type of fuel used. The cleaning would normally be done prior to the start of each winter

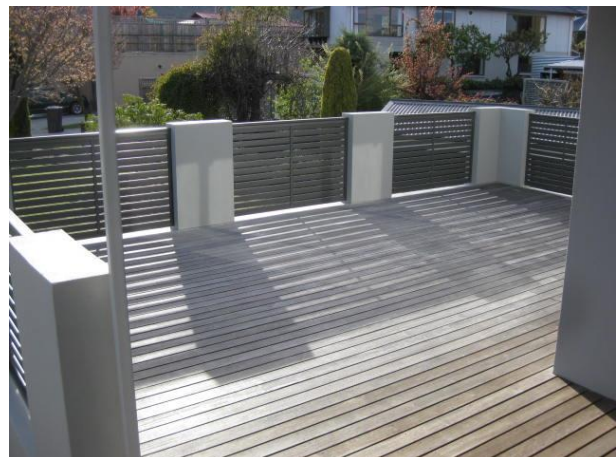
Off living room.  
Concrete block perimeter wall with tantalised timber piles,  
with hardwood decking over timber floor joists.  
All appears to be in reasonably tidy condition.  
Fitted.

Balustrade

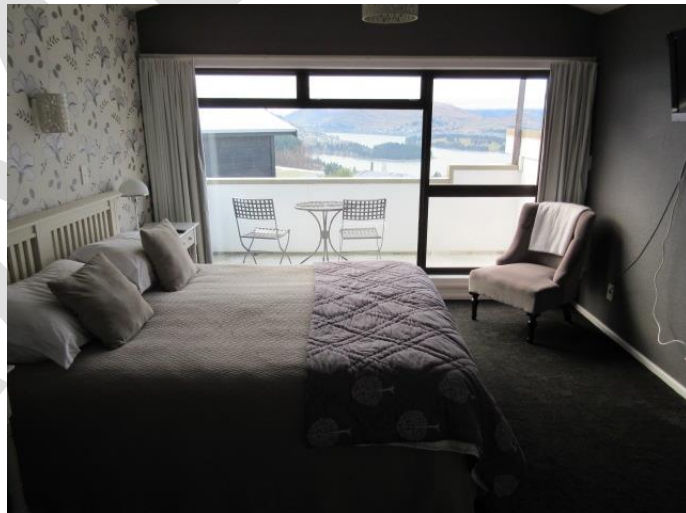
Note: Wardrobe door requires easing.

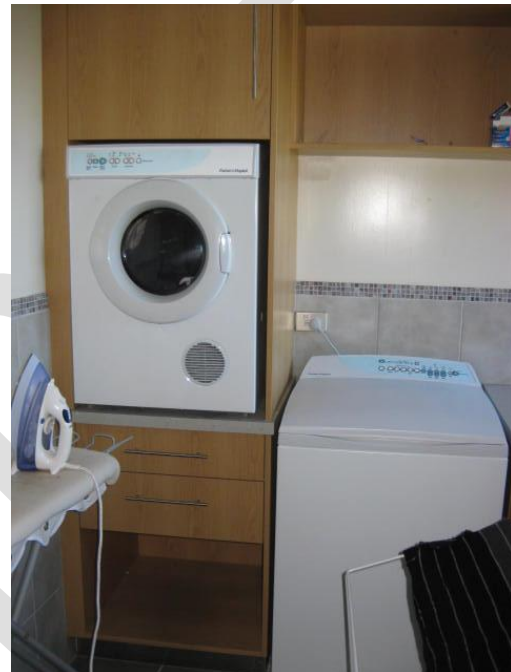
**Note:** There is a small leak under 'Super tub'.

Fit seismic restraints to hot water cylinder.  
Have leak under laundry 'Super tub' repaired.  
Have the 'Body Corp.' minutes checked.  
Have qualified plasterer check and repair exterior plaster cladding.  
Have qualified painter re-paint the exterior plaster cladding with the appropriate paint.  
Confirm if an 'Energy Work Certificate' is available for gas installation.  
Lower ground levels where required.  
Rectify damage from moisture ingress into wall framing.  
Ceiling insulation must be moved/kept 150mm away from un-rated down-lights.  
Obtain 'Code of Compliance Certificate' for .....  
Obtain 'Certificate of Acceptance' for .....

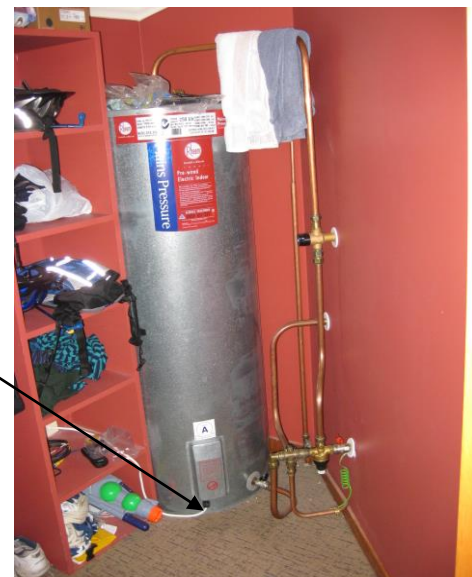
- Mounted on the floor.
- 
- Condition: Not all of the cylinder could be accessed for inspection due to its location. No corrosion or leaks seen to areas that could be accessed.

*Note: There is no drainage tray under the hot water cylinder*

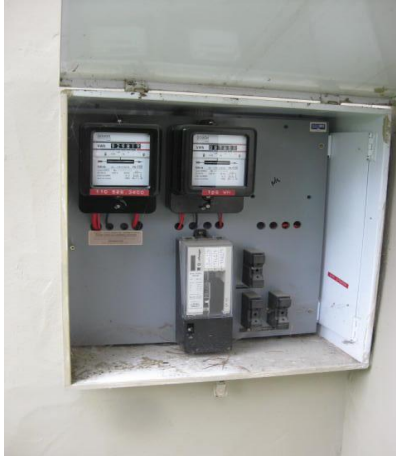
Exterior meter box

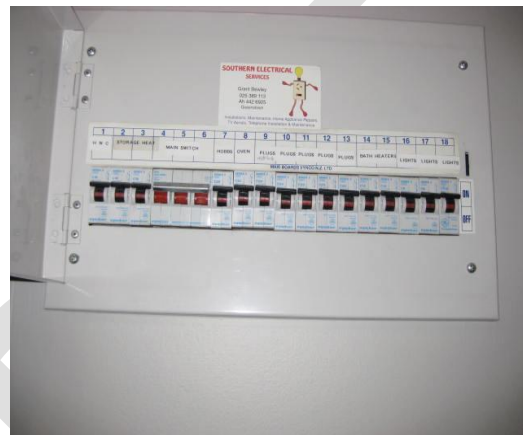
Switch board
