## 4 Example Street Arrowtown

- 2.1 This report was commissioned by **Joe Bloggs**  
In accordance with instructions I inspected the property at:  
**4 Example Street, Arrowtown**

Date: 03/03/2018 and report as follows:

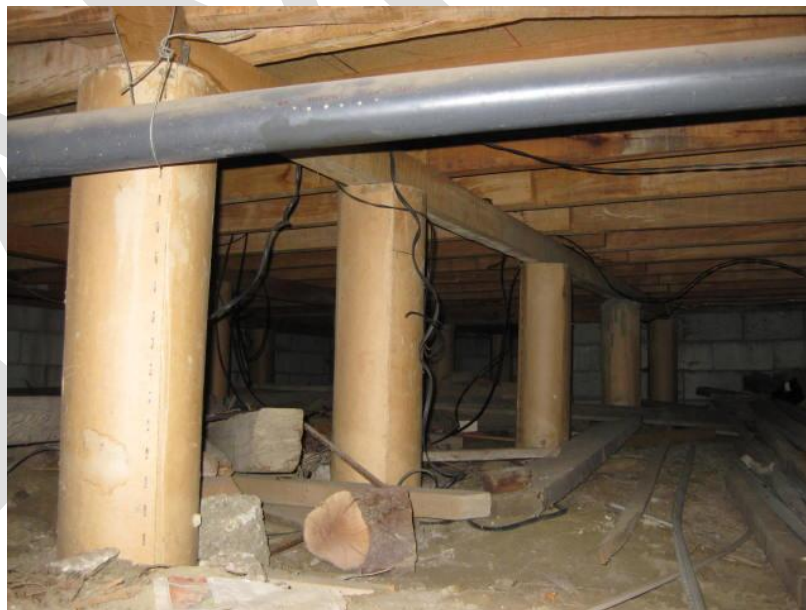
### 4.2 Subfloor Space

Location of access point	Through garage.
Accessibility	Reasonable.
Pile type	Concrete.
Pile to bearer connections	Appear to be adequate.
Bearers, joists and flooring	Those that could be accessed for inspection were found to be in reasonably tidy order.
Drainage	Adequate.
No decay seen during inspection.	
Floor type	Particle board.
Insulation	Nil.
Plumbing	Appears to be in reasonable condition.
Obvious structural alteration	Nil.
Ground under house was dry at time of inspection.	
Ground Vapour Barrier	Nil.
<b>Note:</b> Some of the water pipes in the subfloor space require lagging/insulation to be fitted, and other areas require the joints in the insulation to be pulled together and then taped together.	
Ventilation	Adequate.

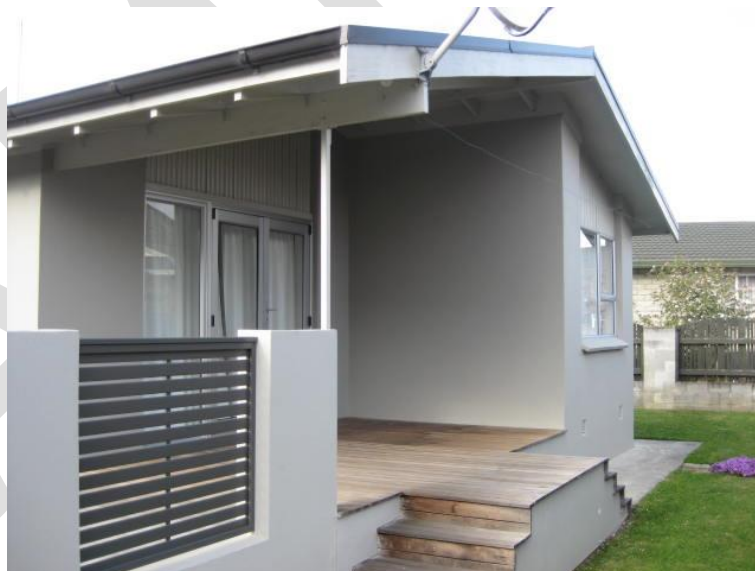
4.19 **Veranda**

Location	Off living room.
Materials	As per dwelling.
Condition	Reasonable for age.

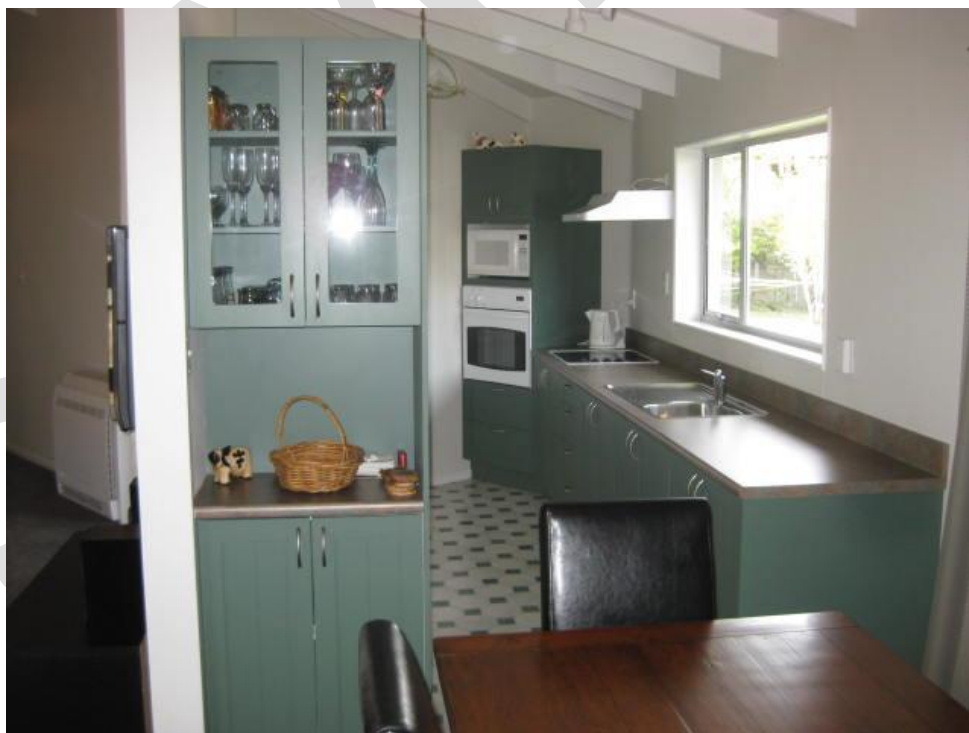
### 5.1 Kitchen

Linings	Gib board walls, ceilings are exposed rafters with pinex sheeting over.
Condition	Reasonable for age.
Floor	Vinyl.
Power points	3x double plus fridge and microwave.
Telephone j/p	Fitted.
Oven	Model: 'Keba' wall mounted oven. Thermostat and simmerstats not tested.
Cook top	In-bench smooth top to match. Elements operational at time of inspection.
Range hood	To match. Extracts to exterior.
Sink	Stainless steel drainer insert.
	Waste disposal not tested.
Bench top	Formica bench top.
Cabinetry	As new.
Heating	Nil.
Window	Operates correctly and single glazed.

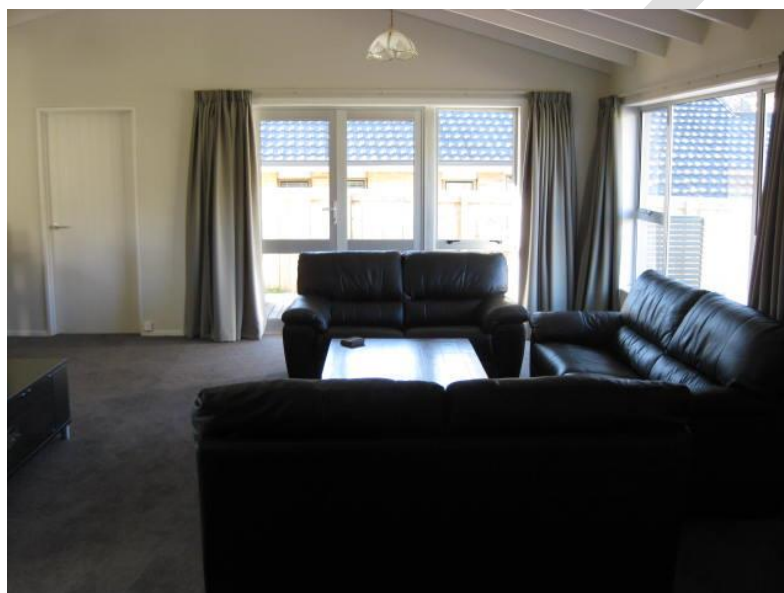
## 5.2 Living/Dining Room

Linings	Gib board walls, ceilings are exposed rafters with pinex sheeting over.
Condition	Reasonably tidy.
Floors	Carpet.
Power points	2x double, 2x single.
Telephone j/p	Fitted.
Heating	Floor mounted 'Daiken' heat pump.
Windows	Operate correctly and are single glazed.
Smoke Detector	Nil.

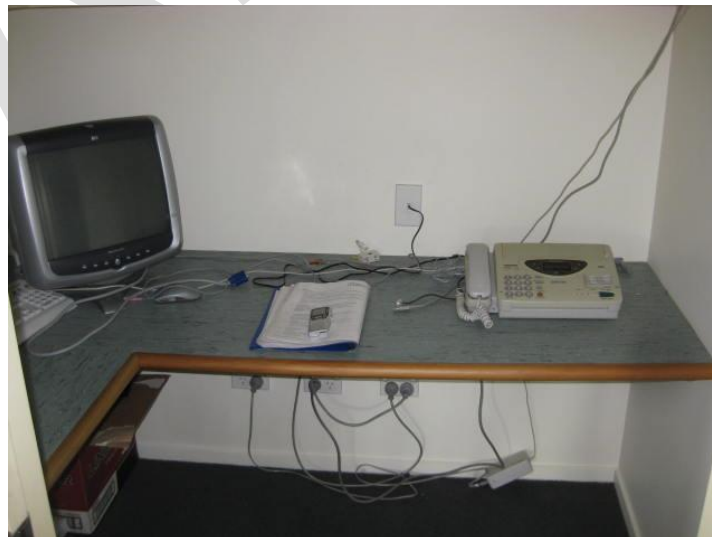
5.9 **Office**

Linings	Gib board walls and ceilings.
Condition	Reasonable for age.
Floors	Carpet.
Power points	2x double.
Telephone j/p	Fitted.
Wardrobe/Storage	Built in.
Windows	Operate correctly and are single glazed.
Smoke Detector	Nil.

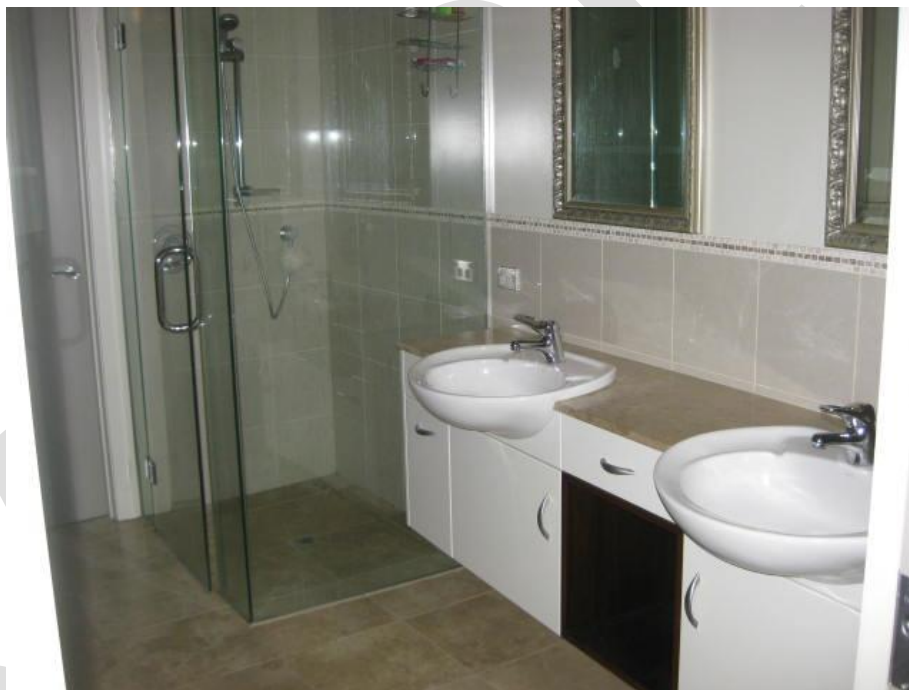
5.10 **En-suite (Off Bedroom 1)**

Linings	Gib board and tiled walls, gib board ceilings.
Condition	Tidy.
Floors	Tiles.
Decay	None seen at time of inspection.
Shower	Tiled shower with glass return and door.
Bath	Nil.
Power points	1x double.
Wall heater	Fitted.
Heated towel rail	Not tested.
Heating	Under floor heating fitted, not tested.
Vanity unit	Wall hung vanity unit with twin porcelain basins.
Wc/Cistern	Operates correctly and is in reasonably tidy condition.
Window	Operates correctly and is single glazed.
Ventilating fan	Fitted.
Taps	Operate correctly and with reasonable pressure.

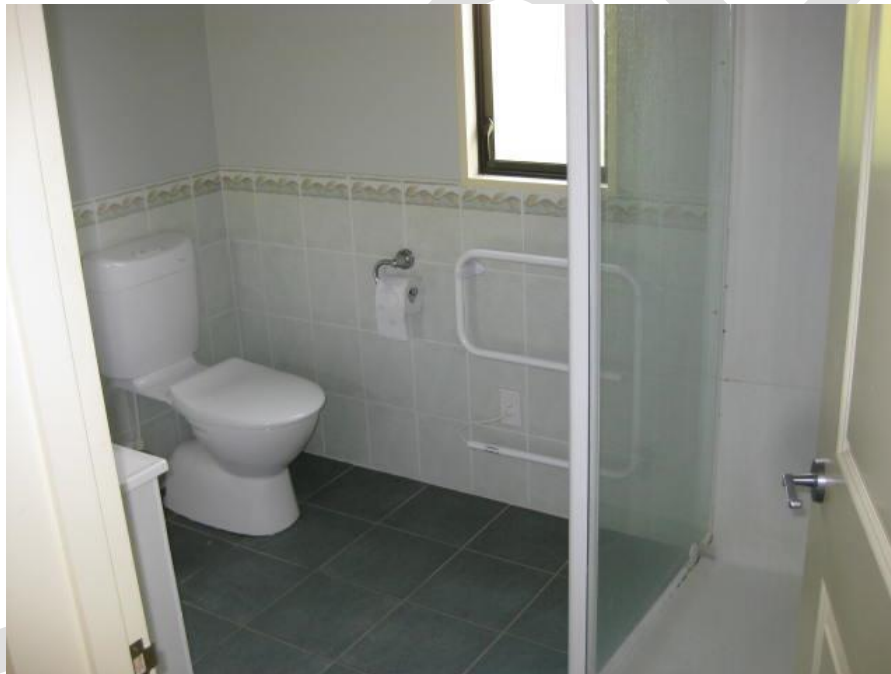
## 5.11 Bathroom

Linings	Gib board walls and ceiling.
Condition	Reasonable for age.
Floors	Tiles.
Decay	None seen at time of inspection.
Shower	Acrylic liner with aluminium framed side panels and door.
Bath	Fibreglass bath, in reasonably tidy condition.
Power points	1x single.
Wall heater	Fitted.
Heated towel rail	Fitted, not tested.
Heating	Under floor heating, not tested.
Vanity unit	Built in vanity unit, in reasonably tidy condition.
Wc/Cistern	Operates correctly.
Window	Operates correctly and is single glazed.
Ventilating fan	Nil.
Taps	Operate correctly with reasonable pressure.
